## Farming in Protected Landscapes Programme Case Study: Indicknowle Farm

### An overview of the project

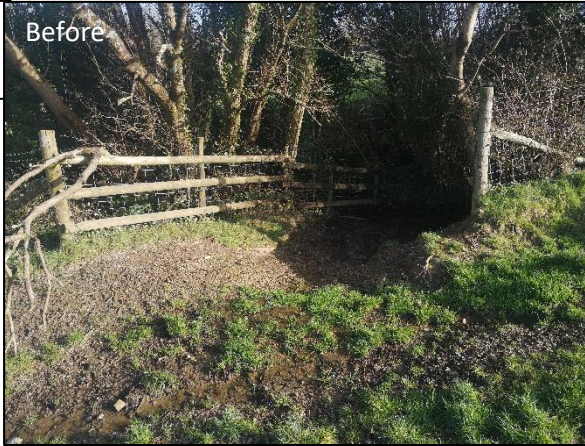
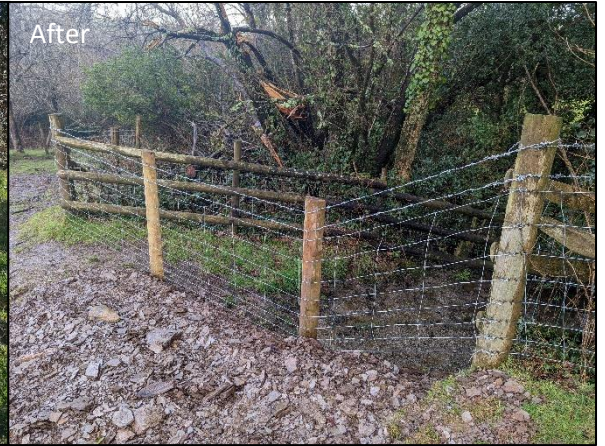
Watercourse  
Fencing

Fencing with sheep netting nearby to the watercourse is usually not supported by the Environment Agency, however in this instance as the channel is so incised, the floodwaters and

any possible woody debris which may otherwise be tangled were considered to not to be able to reach the height of the new fence line and therefore supported.

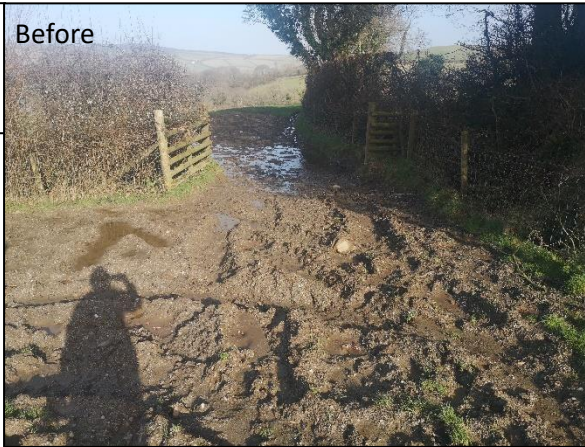
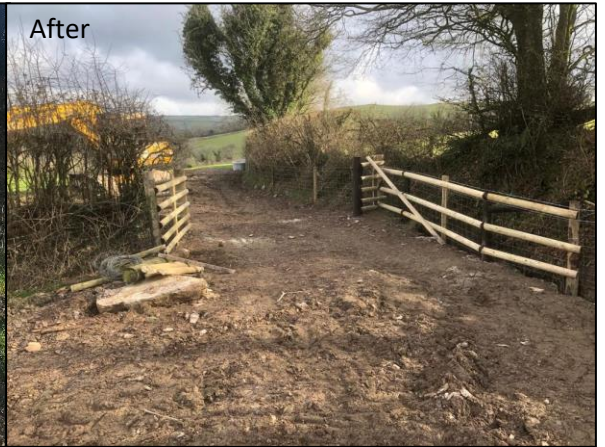
Culvert /  
Crossing  
point

- Installation of a piped culvert within a ditch as crossing point for both machinery and livestock, to provide suitable crossing points for surface runoff beneath a heavily trafficked gateway and reducing sediment and soil mobilisation previously caused by poaching.

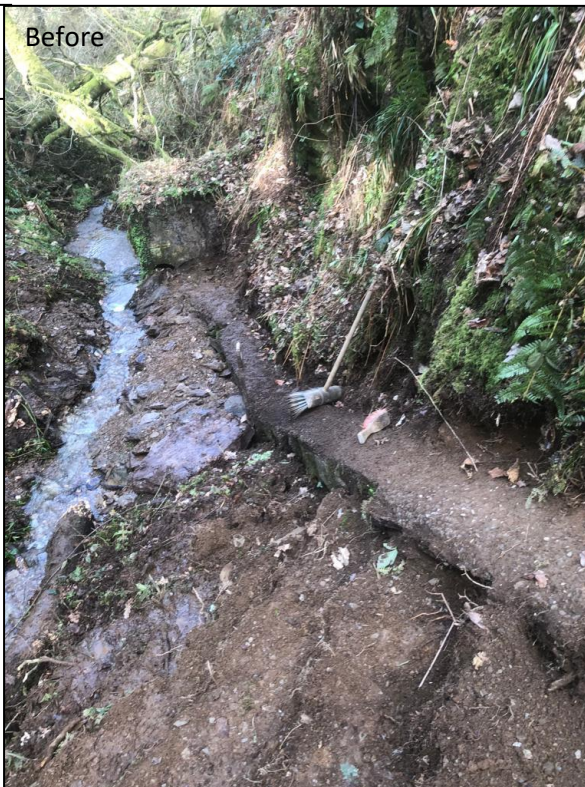
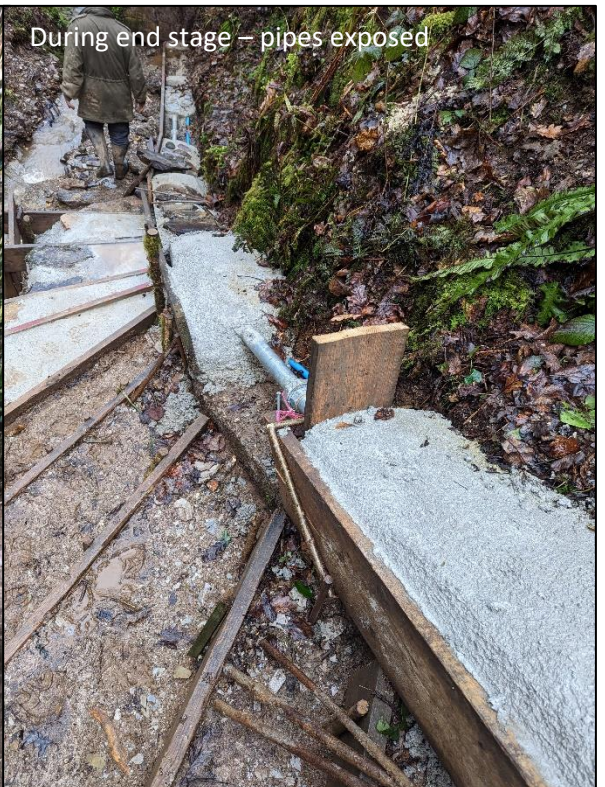
Ram Pump  
Repairs

- Repairs undertaken to an existing ram pump drive pipe supply/system which would support a larger-scale existing water supply system to the whole farm, including water supply for stock, productive orchards, and buildings.

With such improvements/repairs made to the ram pump, it is expected that the system will be able to last a further 40years, continuing to provide the farm, orchards and buildings with water resilience options in times of drought pressures and in the age of variable climatic changes.
